CAMPAIGN DEPLOYMENT REPORT (VIANA DO CASTELO – LOTE 1)

EOL-LO115-V03

EOLOS Floating Solutions has successfully completed the deployment of its metocean buoy unit FLS200 E02 at the Viana Site, for the LNEG wind and metocean measurement campaign.

This document provides a summary of the buoy commissioning at its installed location offshore during the 27th and 28th of June 2025.

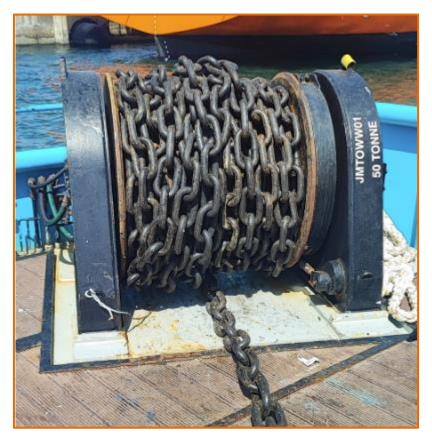
Figure 7: 32mm chain spooled onto the main winch drum.

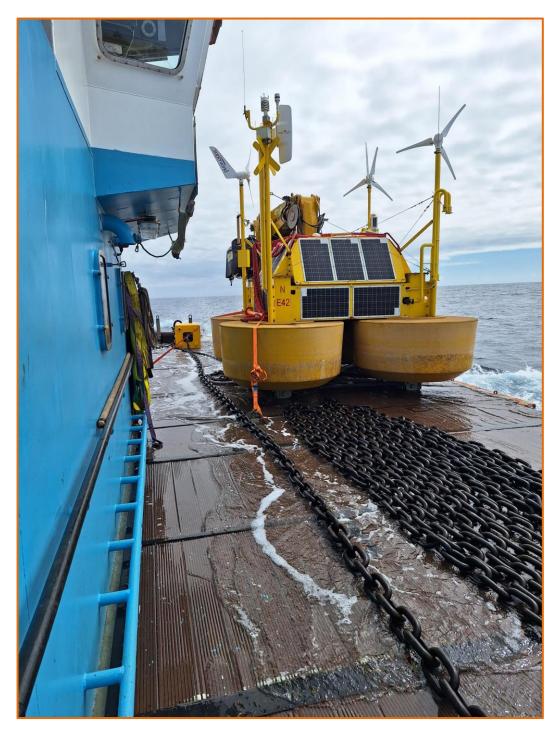
Figure 8: Deck arrangement.

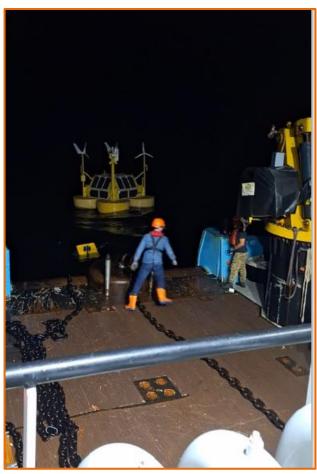
Figure 9: Deployment of floaters.

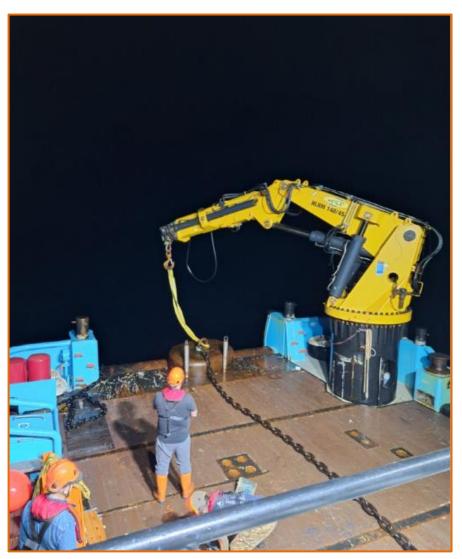
Figure 10: Deployment of CW.

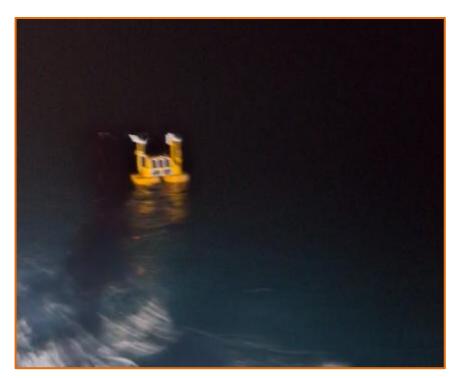
Figure 11: SAT completed.
