# CAMPAIGN DEPLOYMENT REPORT (LEIXÕES – LOTE 2)

EOL-LO208-V02

03/07/2025

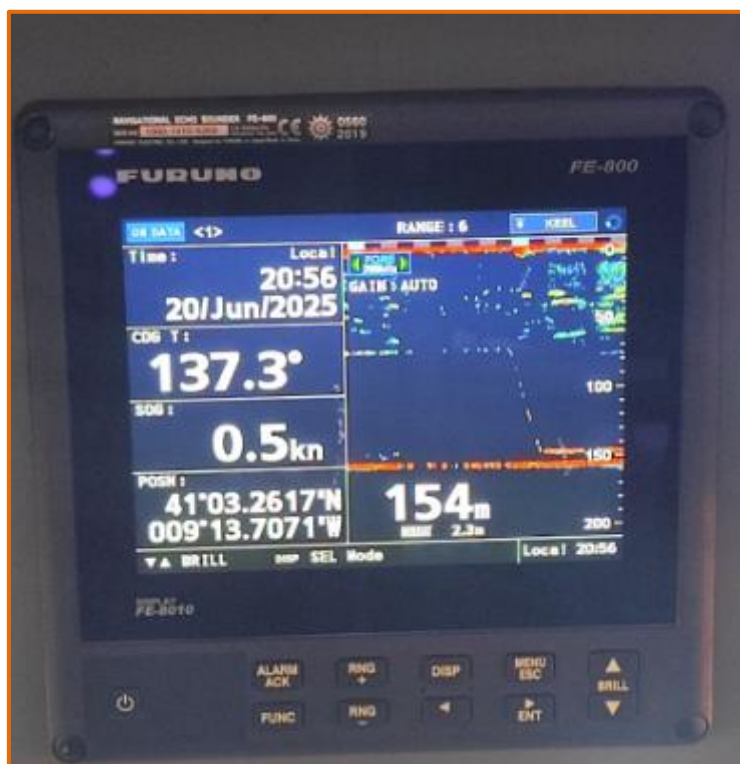
After passing the safety pin of the quick release, the captain heaved in the main winch wire, transferring tension to the quick release and allowing all remaining securing points to be safely disconnected. However, it was then discovered that the actual water depth at the site was 154 meters—considerably deeper than the 94 meters for which the mooring system was originally designed. Following an on-site assessment with the EOLOS operations team, it was decided to proceed with buoy deployment while a corrective plan was prepared ashore to add additional chain. This modification was carried out two days later during a follow-up visit to the buoy.

Figure 14: Vessel sound showing the actual depth of the site.

| Hazard Observations | | |
|---|---|---|
| 1. Incident – Incorrect depth | Before releasing the last section of mooring, it was detected that the actual site depth was considerably different from the depth initially informed to EOLOS. The buoy was deployed anyway, and a corrective action to solve this issue arranged. | Check actual site depth before starting the operations. |

See document EOL-LO209-V01-OPS-Corrective Maintenance Report (20250622).
